Lymington to Yarmouth Ferries: Third Annual Mitigation Review

Progress Report 3 and 8th Report for the Environment Management Panel

Report R.2313

December 2014

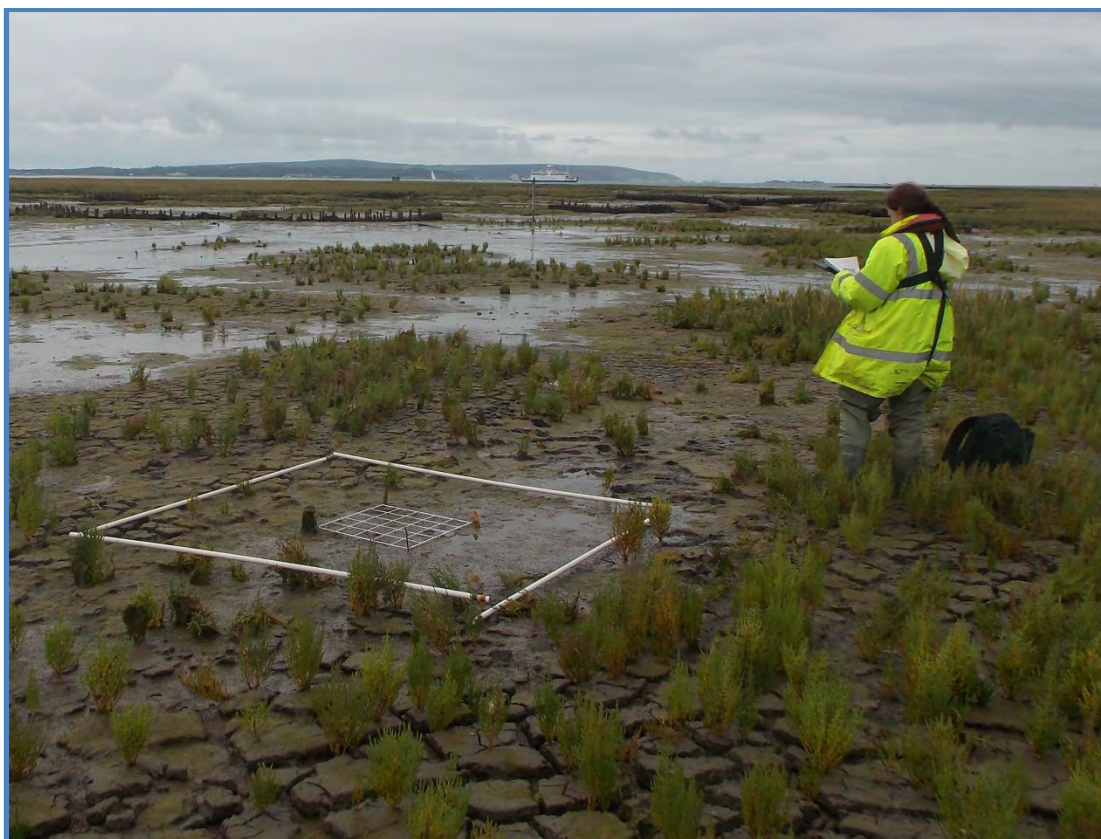
Image 1. View of the recharge area September 2014

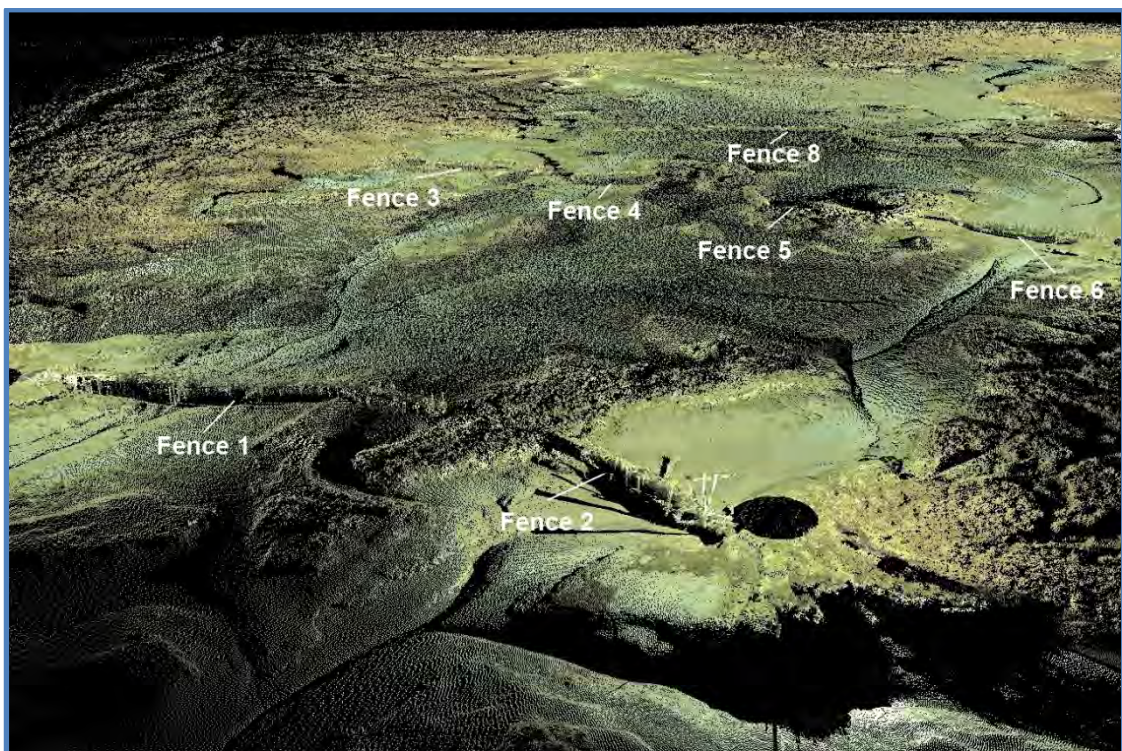
Image 2. 'Aerial' view of recharge from CCO laser elevation survey April 2014

In addition, the CCO has also begun collecting survey data at this location. They carried out a laser elevation survey of the recharge area just before and just after the 2013 recharge (in October 2012 and April 2013 and April 2014). This data can be used to define with a relatively high level of accuracy the changes in bed elevations and the amount of sediment that was retained within the recharge area (Image 2 provides an example output of this work). CCO has provided the results of these surveys and these have been reviewed for this study.

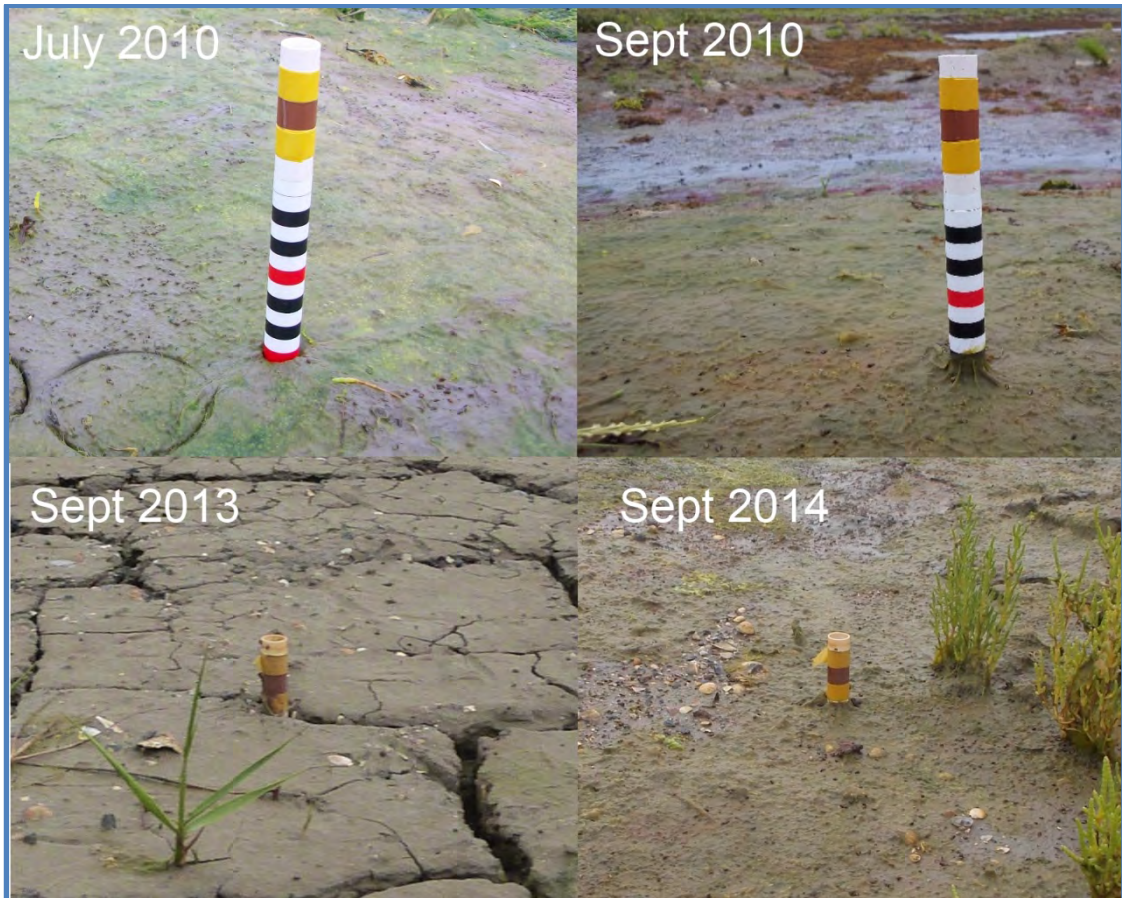
Image 3. Graduated Stake A before and after the 2012 ad 2013 recharge work

To describe the latest conditions on the recharge site, a selection of the fixed-point panoramic photographs (taken on site over the last three years) is shown in Appendix A. The results of the sediment elevation changes at each of the graduated stake locations are also shown in Table 1 and in Images 3 and 4.

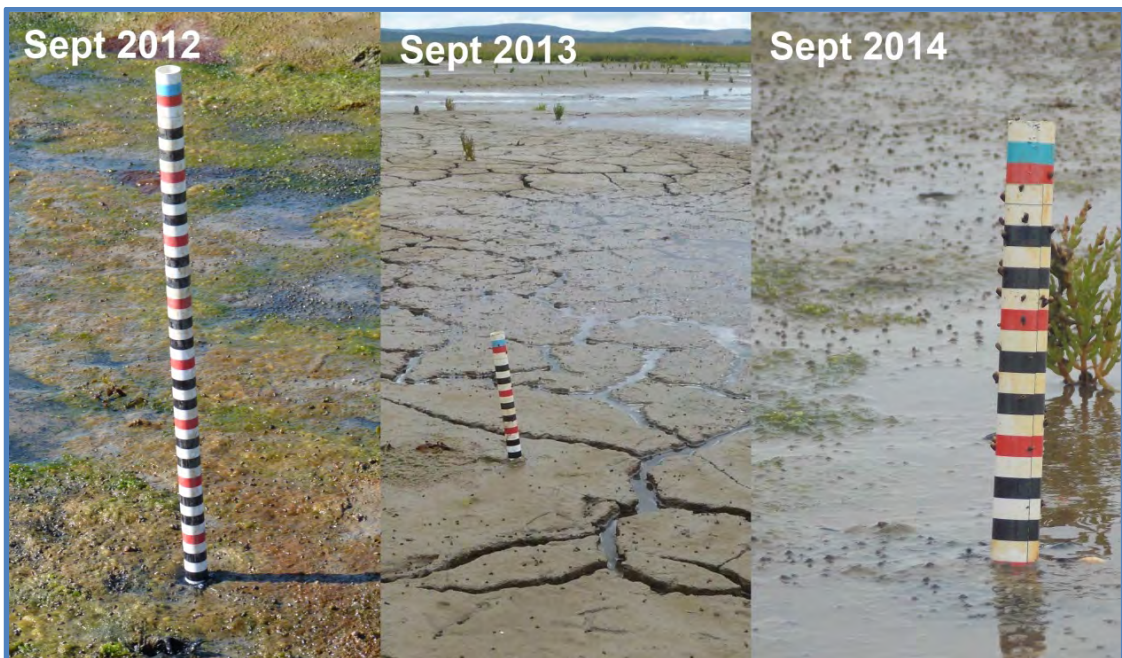
Image 4. Graduated Stake I after the 2012 and then 2013 recharge work

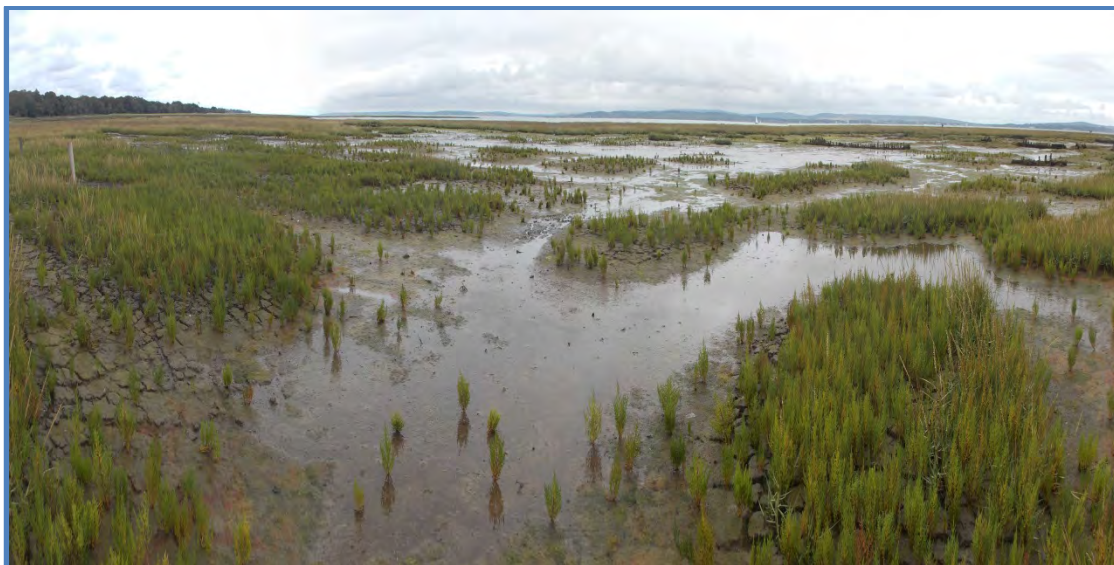
Image 6. View from BP2.5 September 2014 showing plant colonisation in the northern part of recharge area

Within the recharge area the marsh has been expanding with plant colonisation (mainly *Salicornia* and *Spartina* spp.) occurring across approximately 10% of the area (see Images 1, 5, 6 and 7). As noted previously this 10% in the northernmost half of the site occurs in areas where the sediment is highest and, hence, the frequency of tidal inundation is lowest. Plant density/coverage within this area is still relatively low, but the observed pattern of colonisation is in keeping with other previous recharge projects. It usually takes 4 to 5 years to achieve 100% plant coverage over initially barren sediment in areas that have an appropriate elevation and good drainage.

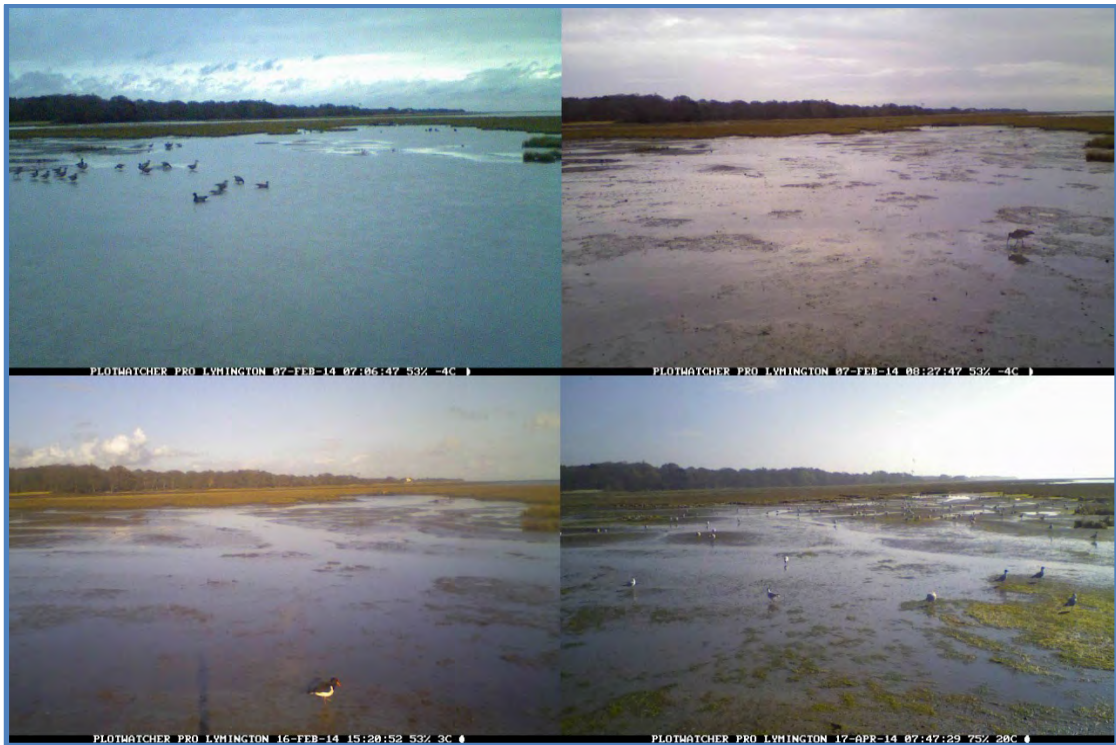
The results show that the site continues to have a low value for feeding and roosting wader species. It provides a well-used roosting location, and occasionally a feeding site for gull during the breeding season. It is functioning as expected for a high level mudflat at and near the mean high water mark.

Image 8. Waterbirds feeding and roosting in the northern part of the recharge area

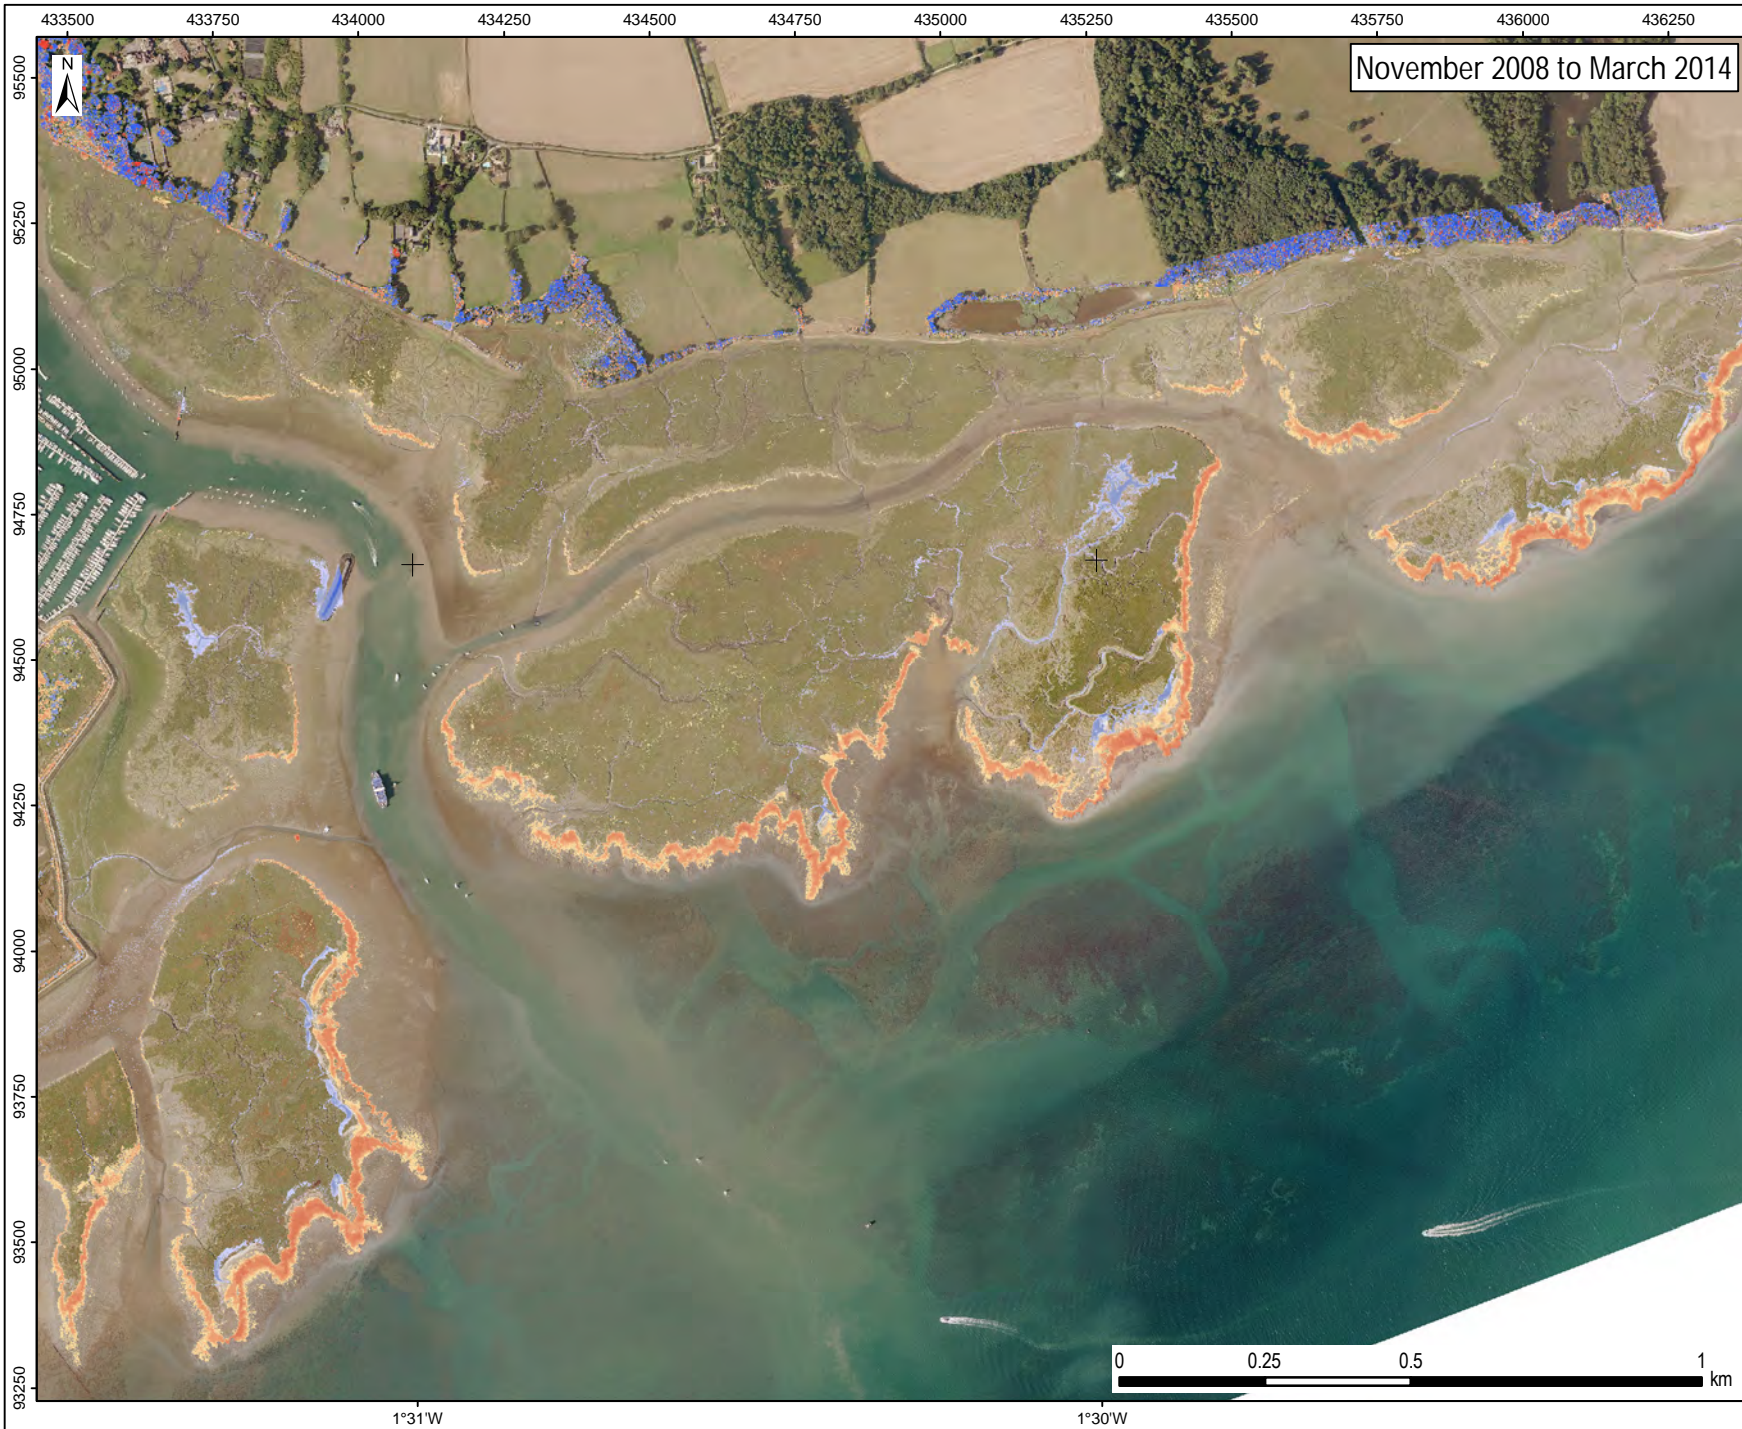
Figure 5

Change in elevation November 2008 to March 2014 (metres)

Changes in habitat elevation along the Lymington frontage using EA LiDAR data

These results continue to show that the quality of the marsh surrounding the recharge area is in decline in many areas. Thus there is a continued process of both external physical erosion and internal qualitative deterioration (referred to as 'pan die back'). The outer exposed face of the marsh is continuing to retreat by around 2 to 3m per year on the exposed eastern face (see Figures 4, 5 and 6).

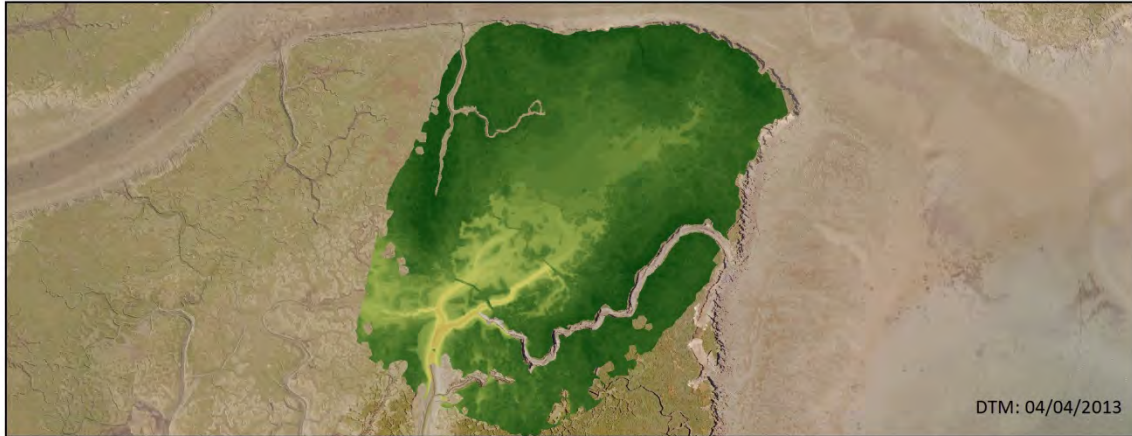
B. CCO Laser Scan Survey Comparison (2013 and 2014)

These findings are also mirrored by the latest CCO survey results. The most recent two surveys were taken immediately after the second recharge in April 2013 and then again a year later in April 2014. Therefore, they describe how the site has developed since the final campaign. Over this post-recharge period these results show that there was a reduction in elevation of the northern half of the site by around 6cm, a relatively stable condition in the central section and accretion of up to 10cm in the southern section and in the small creek at the top of the site (beyond Fence 10). Across the whole site the CCO analysis also indicates a slight net accretion of 100m³ between April 2013 and 2014, and the general changes in elevation from this work are most clearly described by the plot shown in Appendix B.
